Risk Assessments for Gates Other Than Radial Gates

Best Practices in Dam and Levee Safety Risk Analyses

Chapter G-2

US Army Corps
of Engineers®

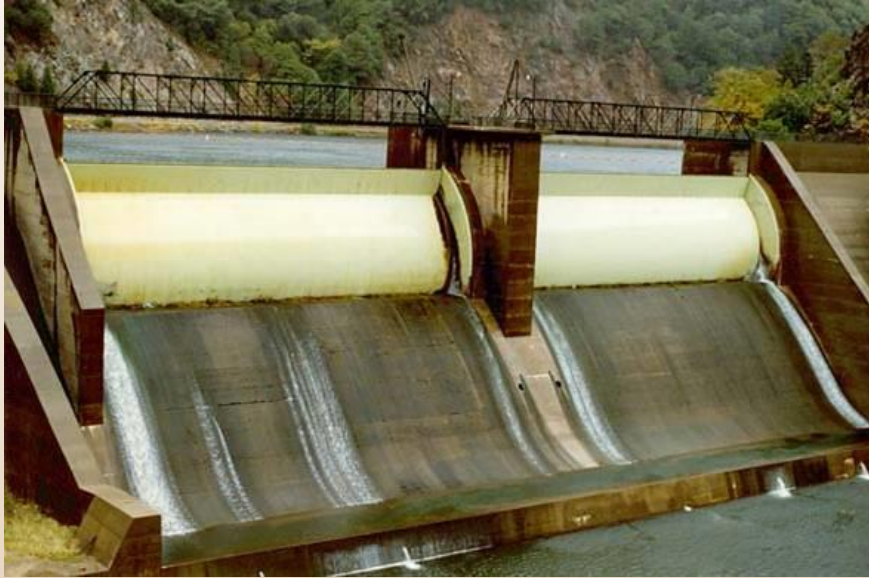
Cresta Dam (PG&E) Drum Gate Incident

- Dam is in Feather River Canyon, CA.
- Owned/operated by PG&E for generation of electric power.
- Two 28-ft diameter by 124-ft long drum gates.
- Summer mid-afternoon in 1997.
- Left side drum gate dropped uncontrollably
- EAP initiated due to dropping reservoir/rising tailwater alarm
- 20-30 minutes to drop completely
- D/S water level rose from 1.6' to 15' in 40 min.
- Maximum downstream discharge ~ 15,100 cfs
- No fatalities

- Failure of drum gate drain line prevented removal of water from inside of gate
- Allowed water into gate through faulty check valve ultimately resulting in the forces acting to lower the gate overcoming the forces acting to raise the gate
- Exacerbating Conditions:
 - Excessive seal leakage
 - Impaired inlet capacity

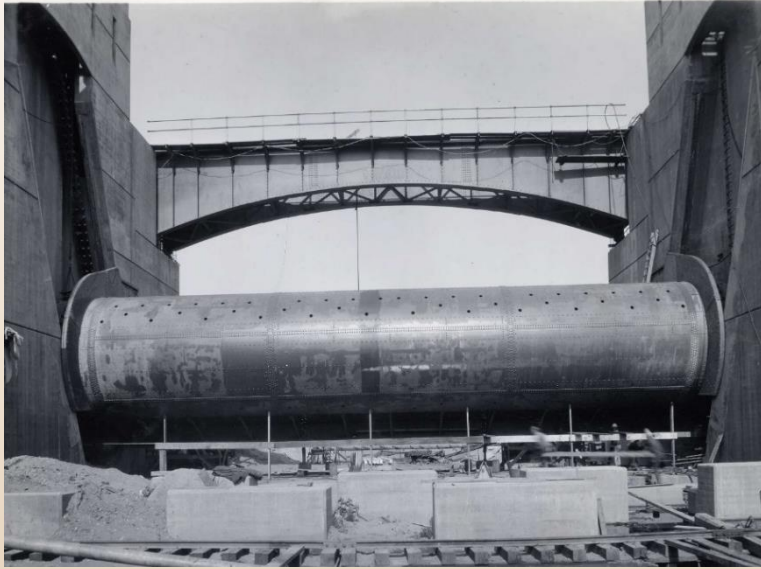
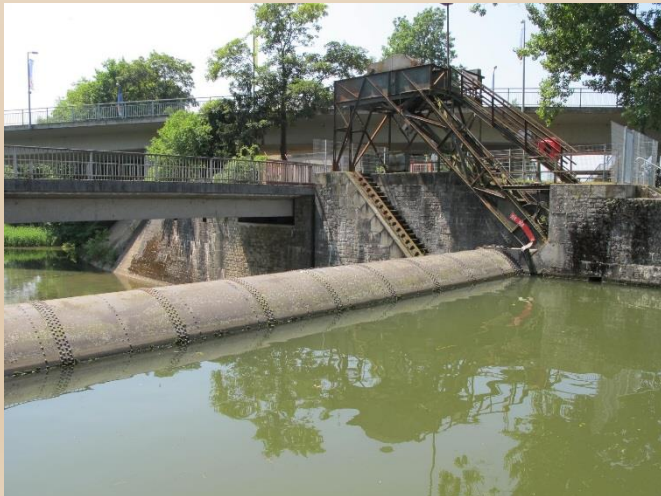
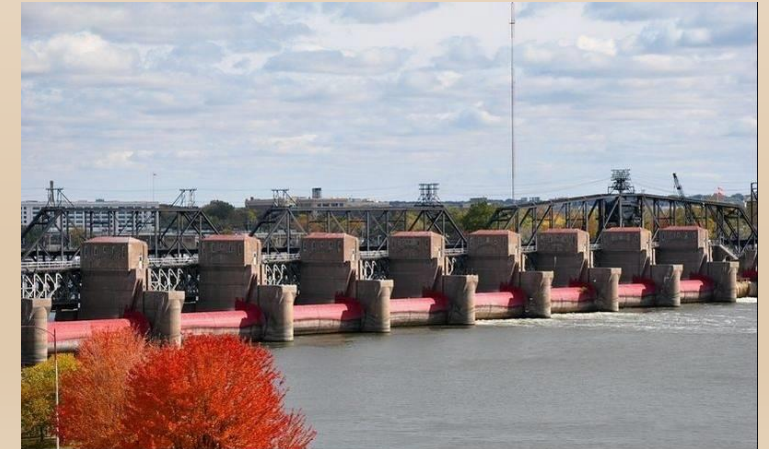
ROLLER GATES

- Simply supported, but internally redundant structures
- Used in older, lower head navigation locks with wide pier to pier distance.
- Steel cylinder, usually riveted.
- Despite no ice loading or seismic considerations in design, these gates have a long history of robust performance on the Mississippi River for low head structures
- Hoisted by chains from one end only – simplifying O&M
- Used to pass ice over the top.
- Significant vibration during lowering of gate has changed operation of dam at certain locations.
- Fatigue cracking has been seen at end frames and at welded details used for repairs or strengthening.

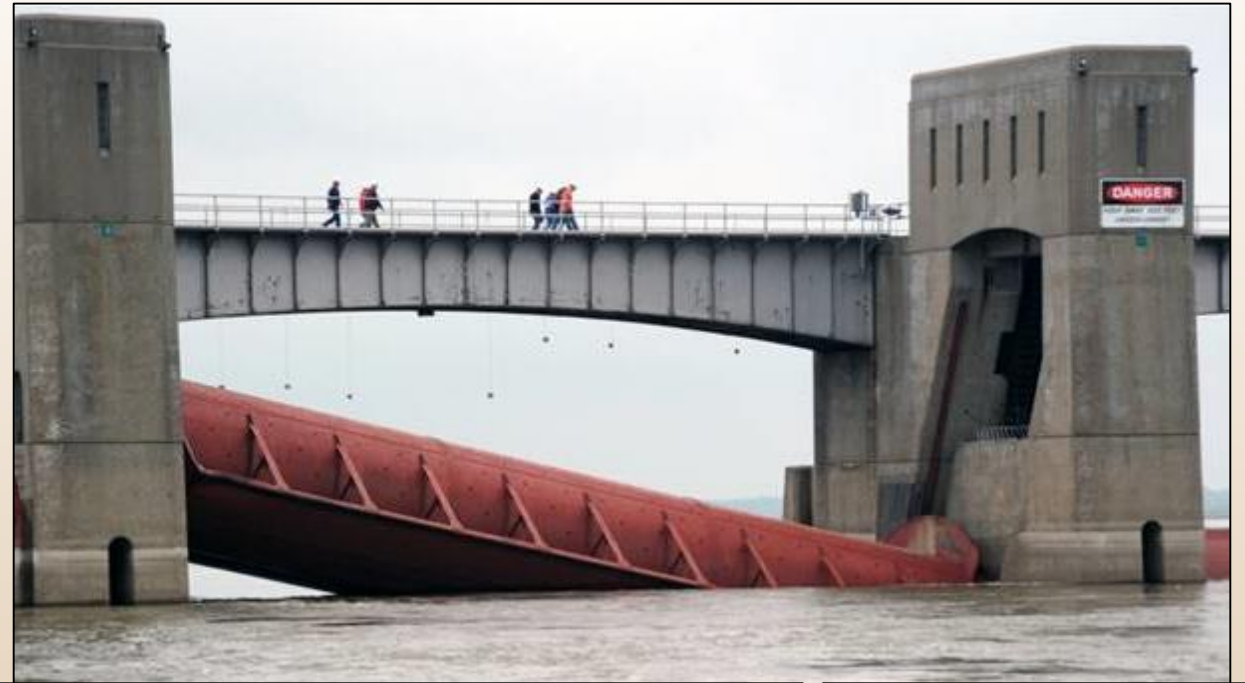
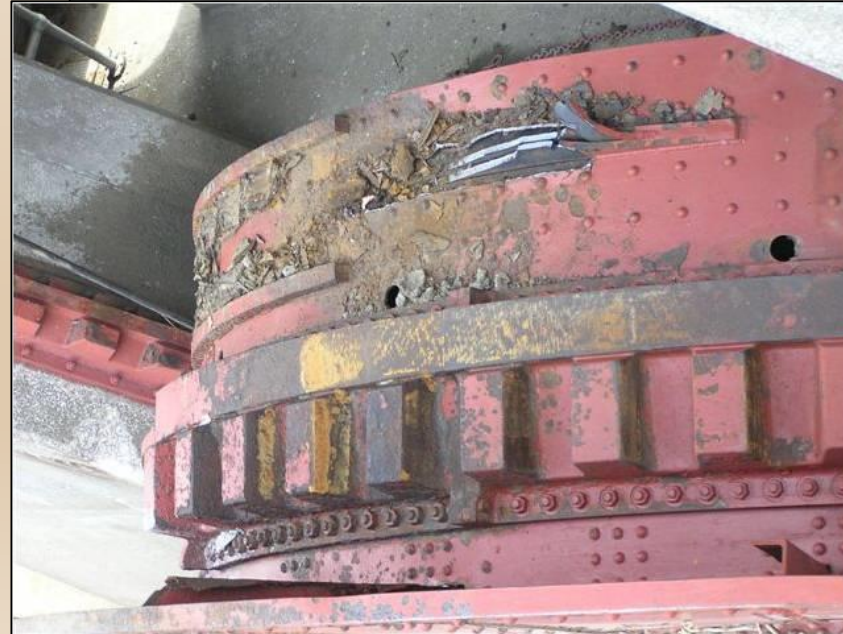
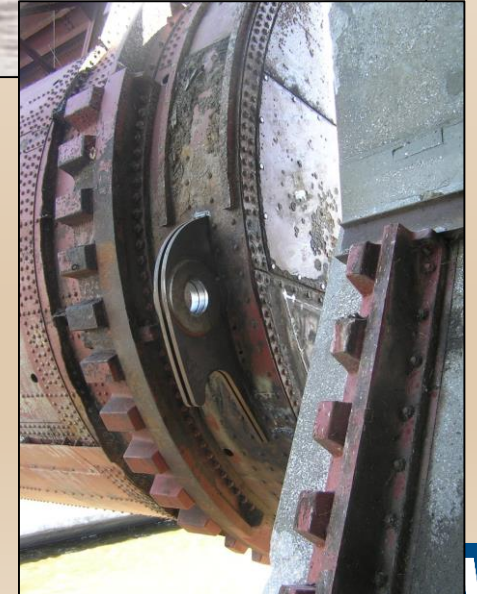
Roller Gate Other Potential Failure Modes

- L&D 25 on the Mississippi River
- April 2010
- Failure of a limit switch that resulted in a roller gate over traveling and coming off the rack.
- The hoist chain failed, the gate fell and became racked.
- The operator, after starting gate movement, walked away and went to operate another gate.
- If the operator had not walked away they would have been able to notice that the gate had over traveled before it came off the rack
- USACE Operations removed the damaged gate and completed repairs.

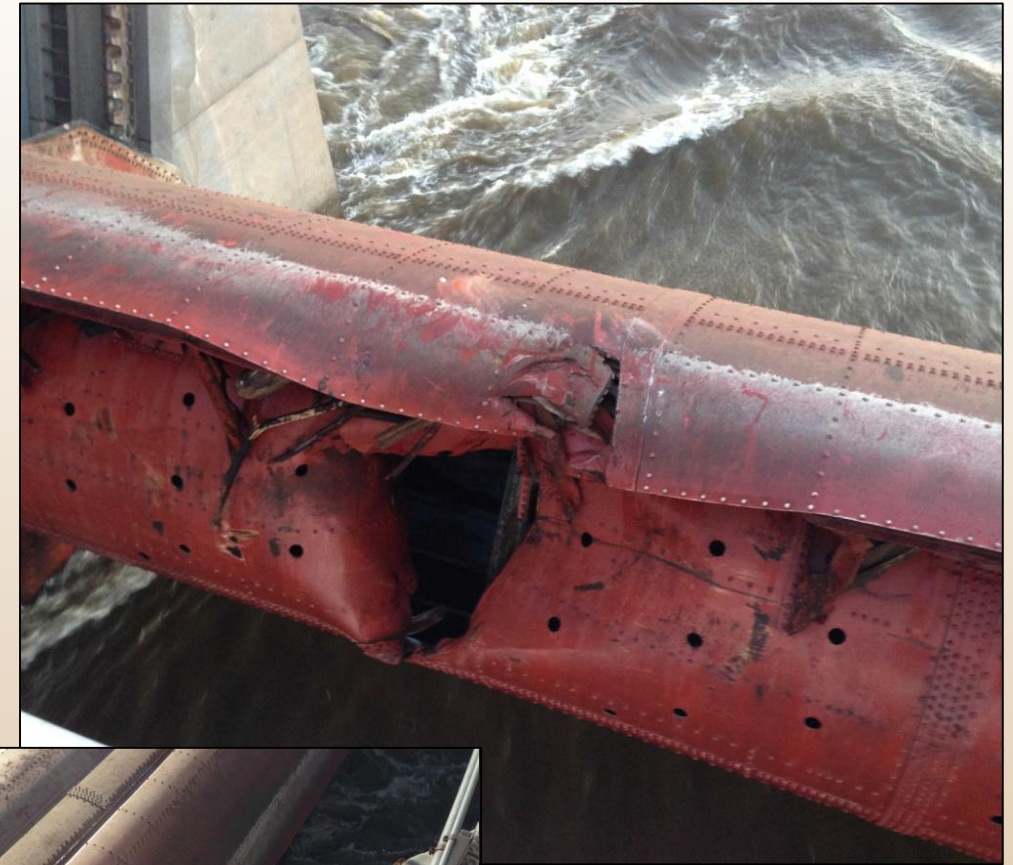
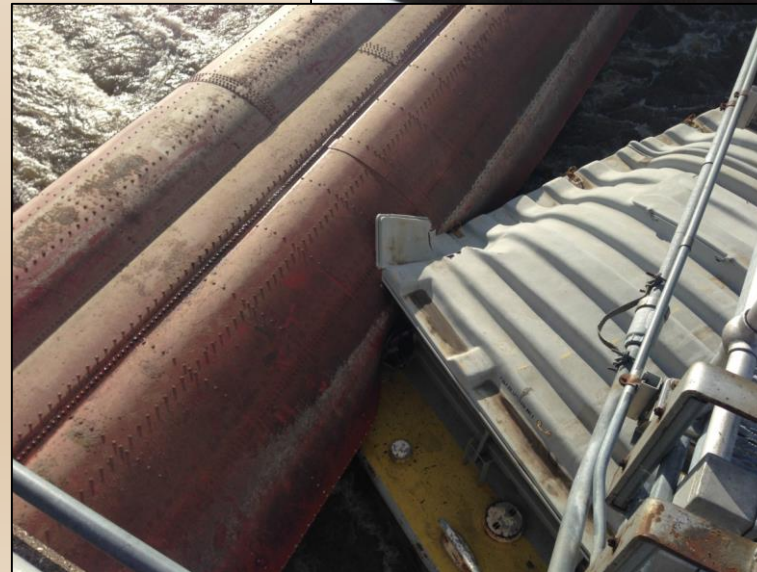
- There have been numerous barge collisions with the roller gates on L&D #3 on Mississippi River
- None have resulted in a loss of pool.
- This page shows concrete-filled barge that impacted Gate 5 on L&D #14 on Mississippi River, July 2014.
- In this case pool was not lost, and gate alignment was not compromised.
- Repairs completed by USACE Operations personnel

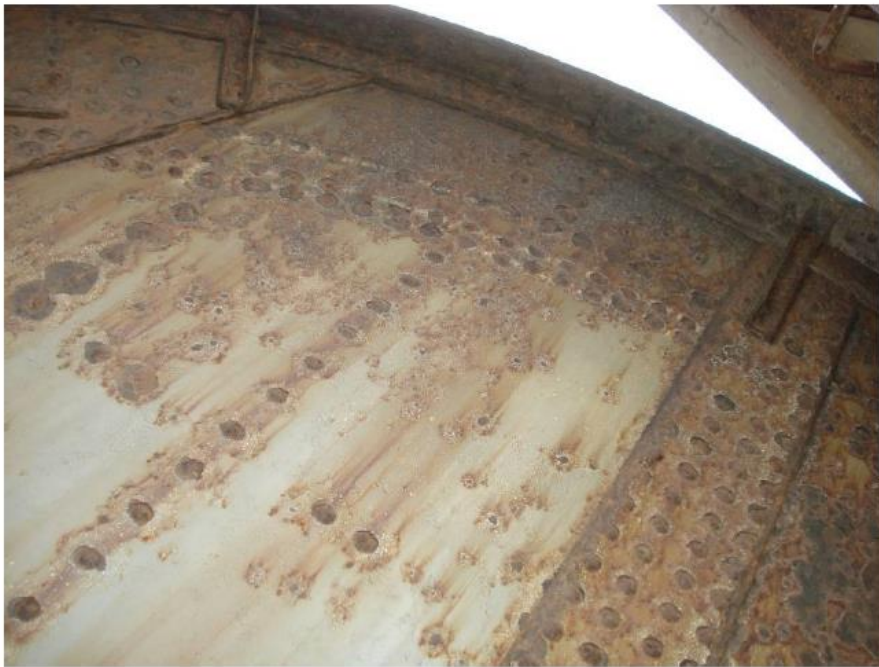
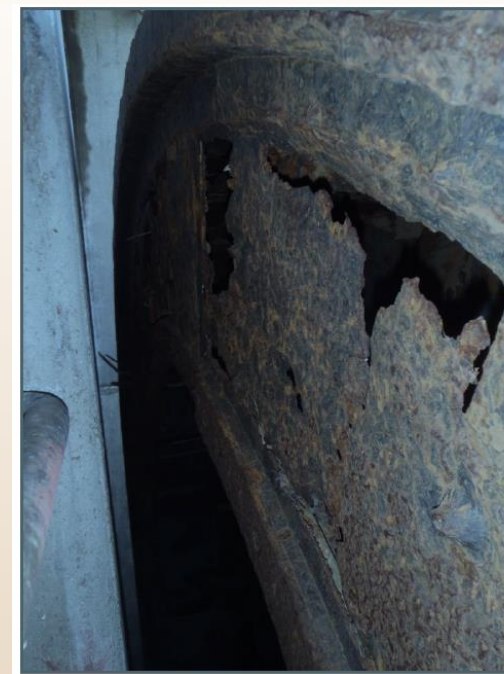
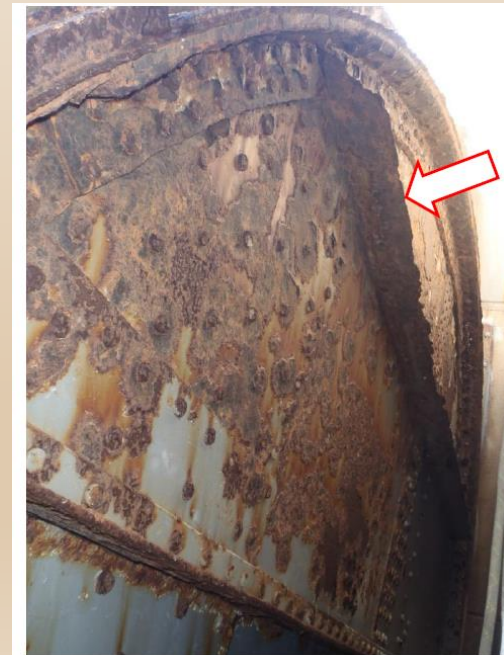
- Corrosion leading to advanced section loss to main load carrying members plus total loss of many rivet heads could lead to sudden catastrophic failure of gate
- Photos from Winfield L&D

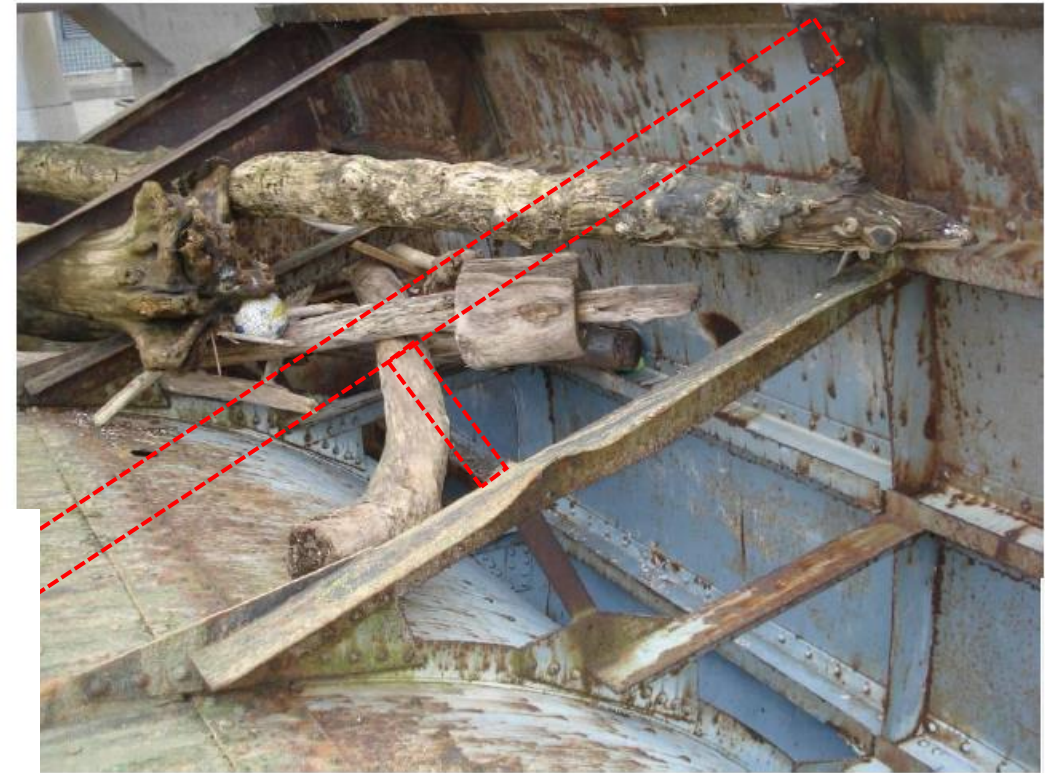
- Damage from debris to apron bracing could lead to collapse of apron and loss of pool – note missing bracing
- Damage to end shields allows debris to foul hoist; gate jams
- Photos from Winfield L&D

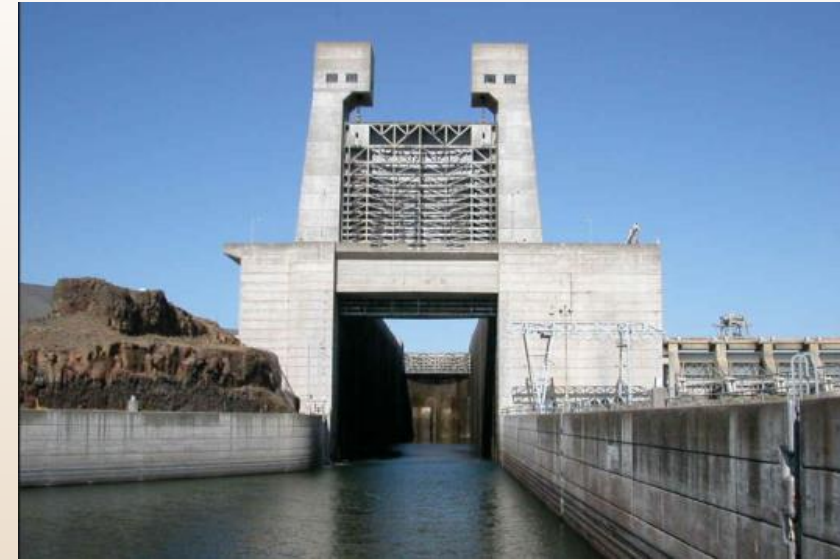
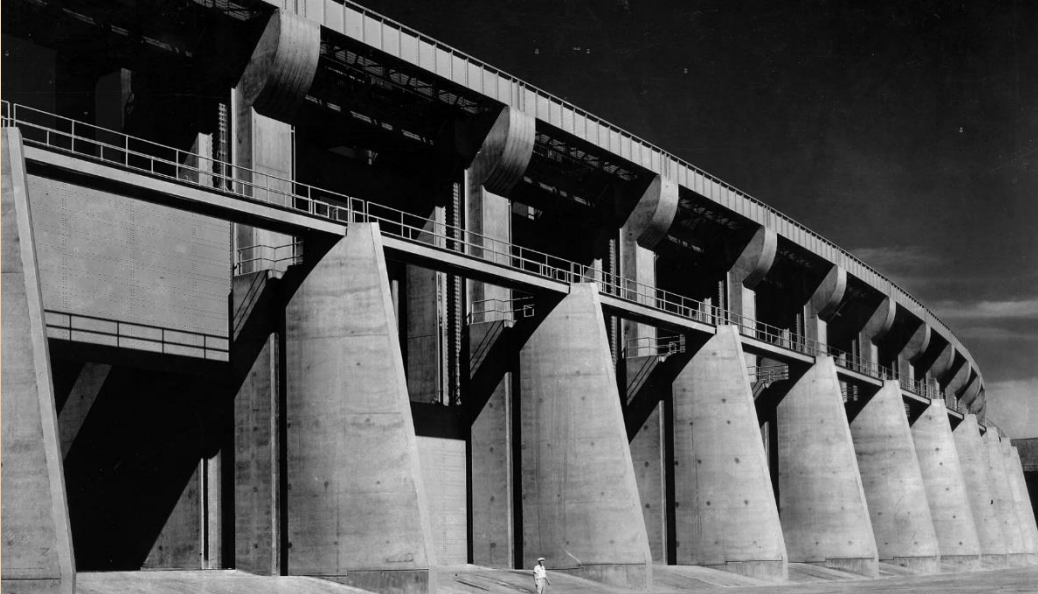
Vertical Lift Gates

- Used both in Navigation and FRM dams.
- For Navigation dams, used in lock chamber and as part of the moveable dam.
- Slide gates or fixed-wheel gates not as susceptible to failure – more robust and loaded in bending (ductile behavior)
- But may have massive hoist house and counter weights that should be evaluated under seismic loading

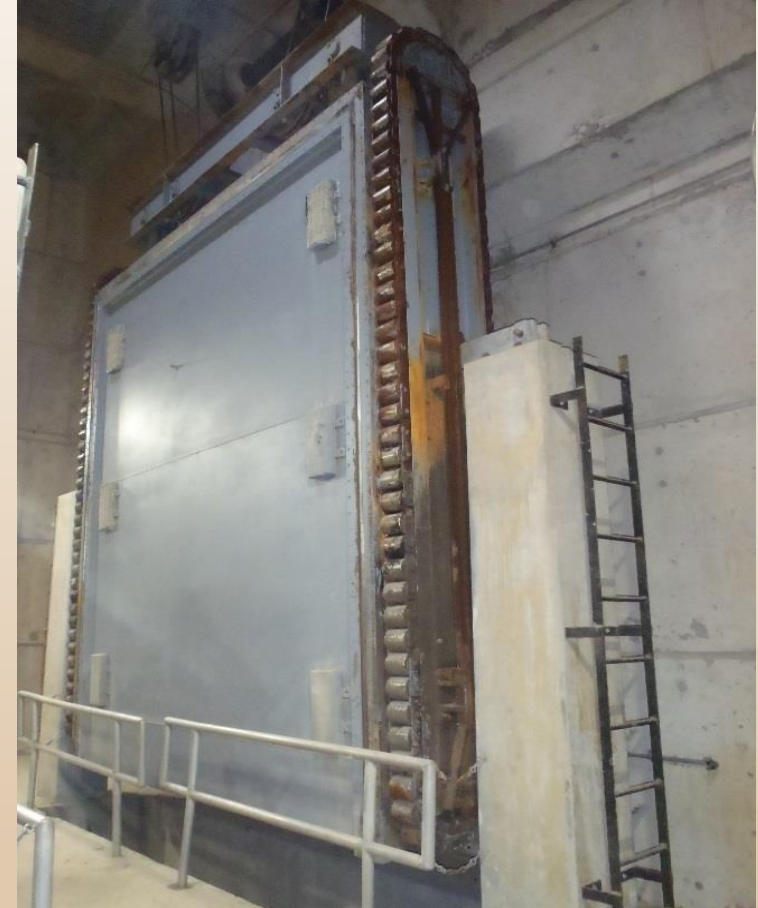
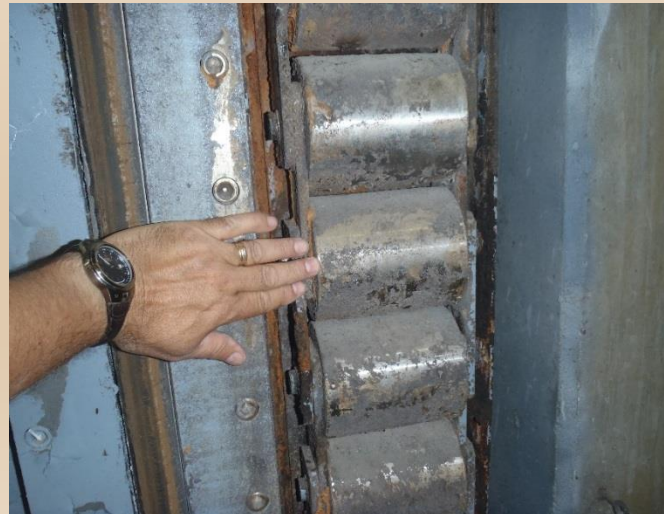
Vertical Lift “Tractor” or “Caterpillar” Gates

- Tractor/Caterpillar Gates are roller-mounted vertical lift gates supported along either side by a continuous series of stainless or carbon steel rollers.
- Otherwise, their construction and function is very similar to that of Wheeled Vertical Lift Gates.
- Serve functionally as service gates, spillway gates, emergency gates and powerhouse closure gates
- Caterpillar Gates are sometimes called Coaster or Tractor gates.
- There are historical problems with the design, leading to decreased reliability.
 - 1. Roller pins or links break, causing chain to separate.
 - 2. Rollers or links corrode and chain does not move.
 - 3. No way to grease or lubricate chain roller pins.
- Found in FRM dams.
- Approximately 288 in USACE inventory

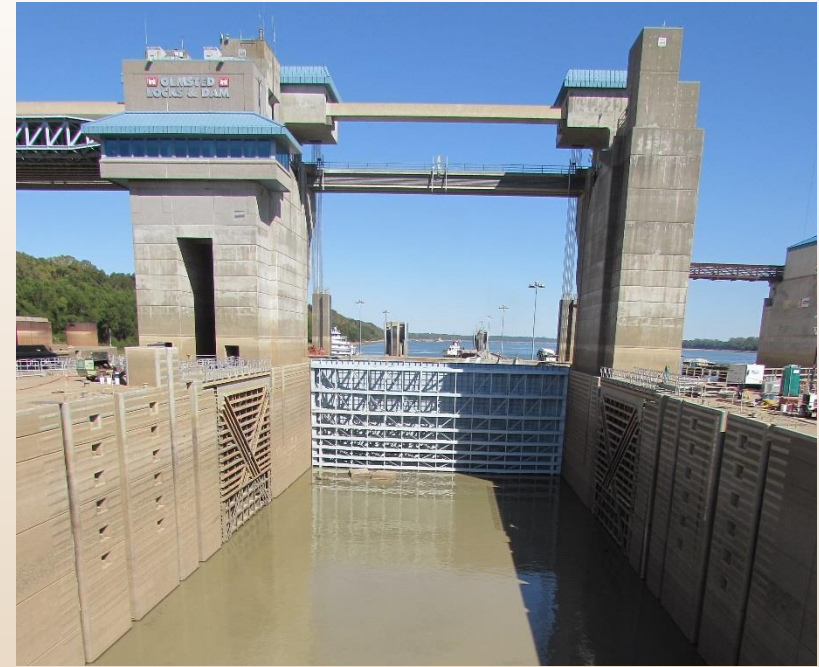
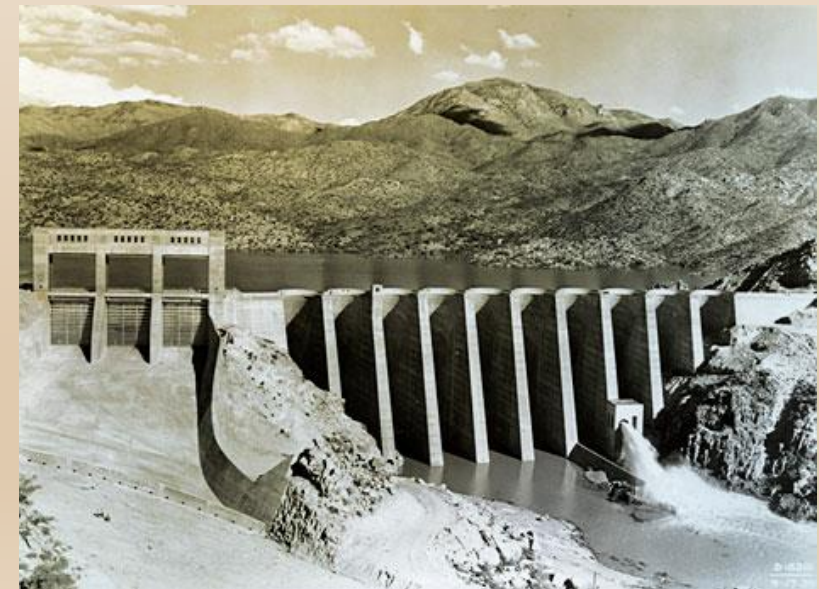
Possible Event Tree for Hoist Houses Seismic Loading

Hoist houses are typically massive structures carrying suspended massive gates - seismic loading is most obvious PFM.

- ↪ Reservoir is at high elevation and vertical lift gate is in fully lowered position, not suspended from hoist house
- ↪ Strong earthquake occurs in weak axis direction
- ↪ Hoist House piers begin cracking as weight of hoist house oscillates
- ↪ Piers fail in moment/shear
- ↪ Hoist houses and piers collapse onto vertical lift gate
- ↪ Vertical lift gate is heavily damaged
- ↪ Rainfall event raises reservoir, gate cannot be operated
- ↪ With spillway unusable, the reservoir rises and overtops dam
- ↪ Dam breaches

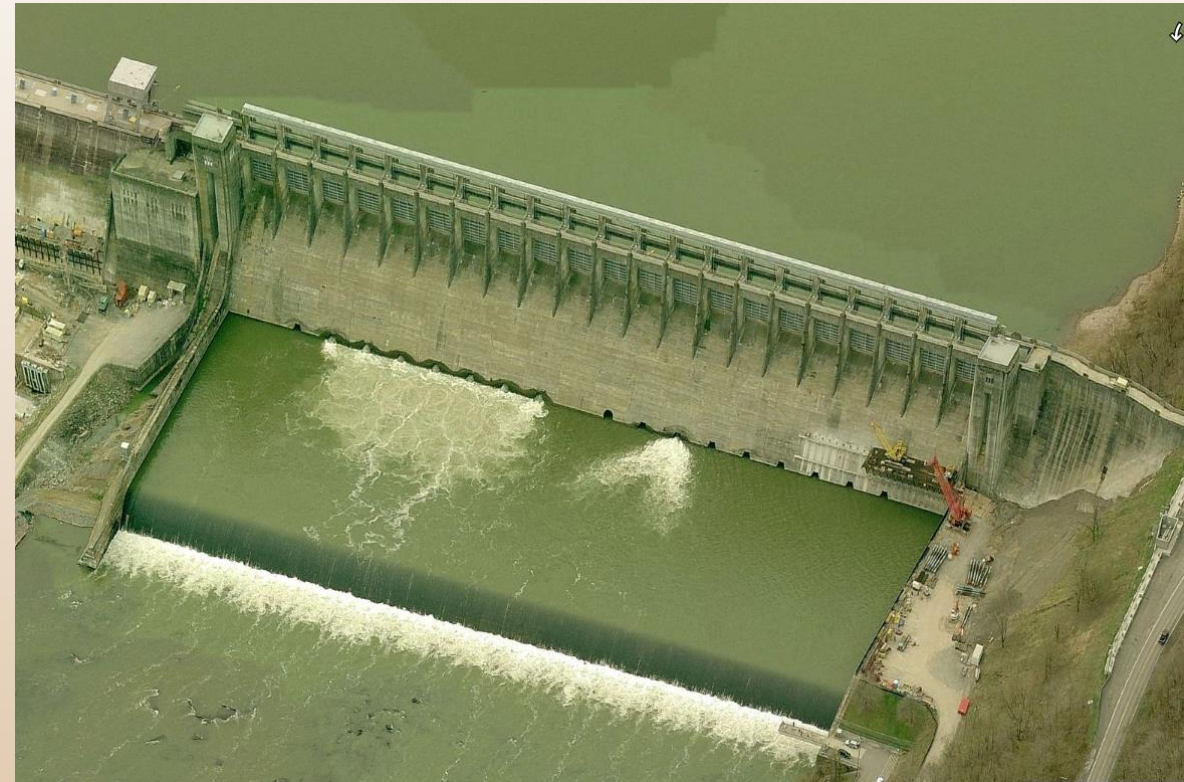
Dams with Multiple Vertical Lift Gates

- Similar to tainter gates on dams, the likelihood of losing pool as the result of the loss of one gate is lower if the dam has multiple gates. The more gates are on the spillway, the lower the likelihood.
- The likelihood of overtopping as the result of the loss of one gate is lower if the dam has multiple gates. The more gates are on the spillway, the lower the likelihood.
- Pascal's Triangle can be employed to estimate likelihood of multiple gate failures

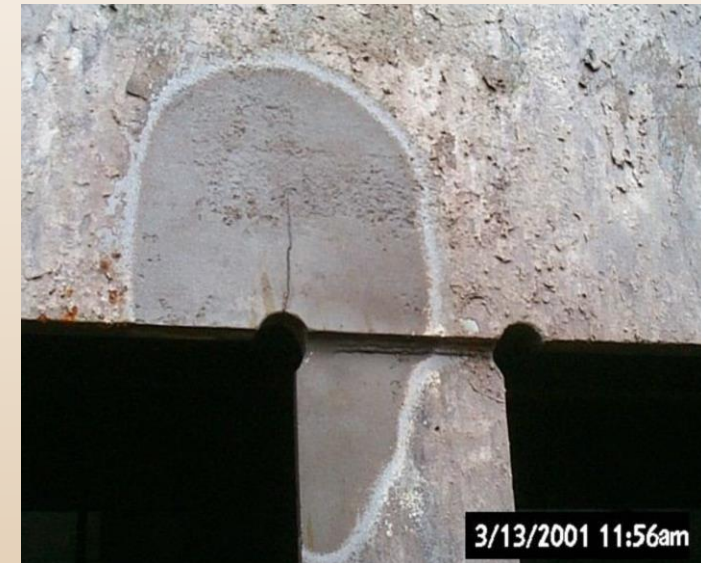
Fatigue Cracking of Vertical Lift Gates

- Fatigue cracking found in vertical lift gates at John Day and Ice Harbor Locks and Dam
- Both had similar design and age.
- Cracking first found at Ice Harbor in 1980 and John Day in 1982.
- Cracking in tension tie at welded connections.
- FEM showed cracking due to exceeded fatigue limit due to cyclic loading.
- Ice Harbor gates replaced in 1996 due to excessive cracking and maintenance. 2 month shut down and cost of \$6.5M.
- John Day gates replaced in 2011 for \$12M.

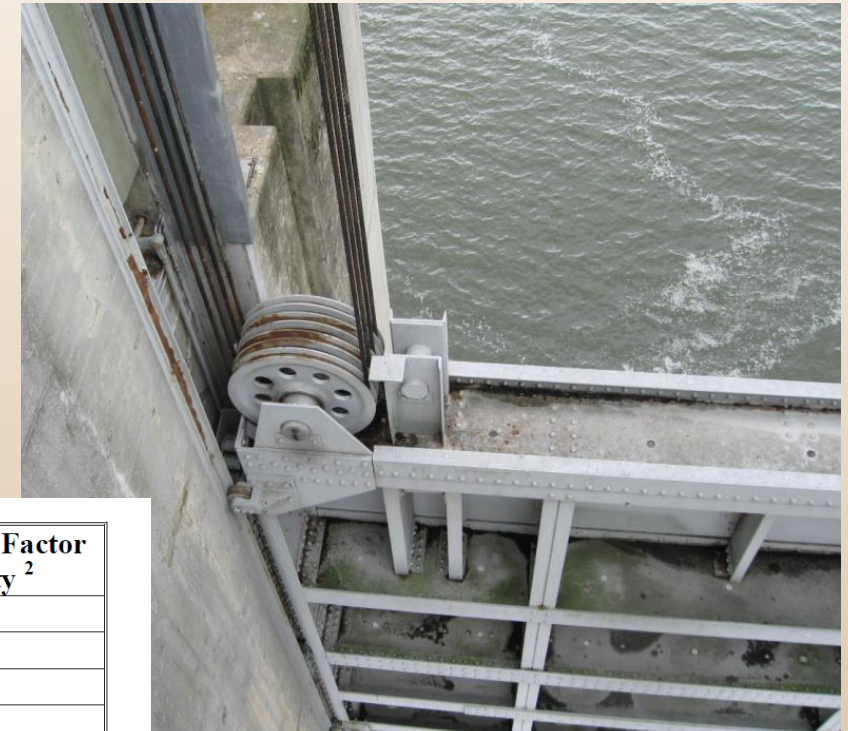
Hoist-Induced Failure of Vertical Lift Gate

- For Bluestone Dam, analysis was performed of hoisting loads on the Hoist Assembly Pin Plate Connection
- Each crest gate weighs 113,000 pounds
- Uninhibited rolling resistance associated with the roller chain assemblies of approx. 2.5% of maximum water load (26,000 lbs.)
- Side seal friction of 175 lb/ft (11,000 lbs.)
- The above assumptions equate to a total normal running load of 150,000 lbs, for which the gate was designed.

Load Condition	Force (lbs)	Pin Plate Factor of Safety ¹	Hoist Rope Factor of Safety ²
Normal Running Load	150,000	2.6	6.05
Hoist Design Load	195,000	2.0	4.66
Hoist Stall Load	487,500	0.8	1.86
Overstress Load	387,800	1.0	2.34
Hoist Rope Failure	487,500 (on one connection)	0.4 ³	0.93 ³

Based on the above factors of safety, the potential exists for the hoist assembly pin plate connection to fail at loads greater than the overstress load of 387,000 lbs.

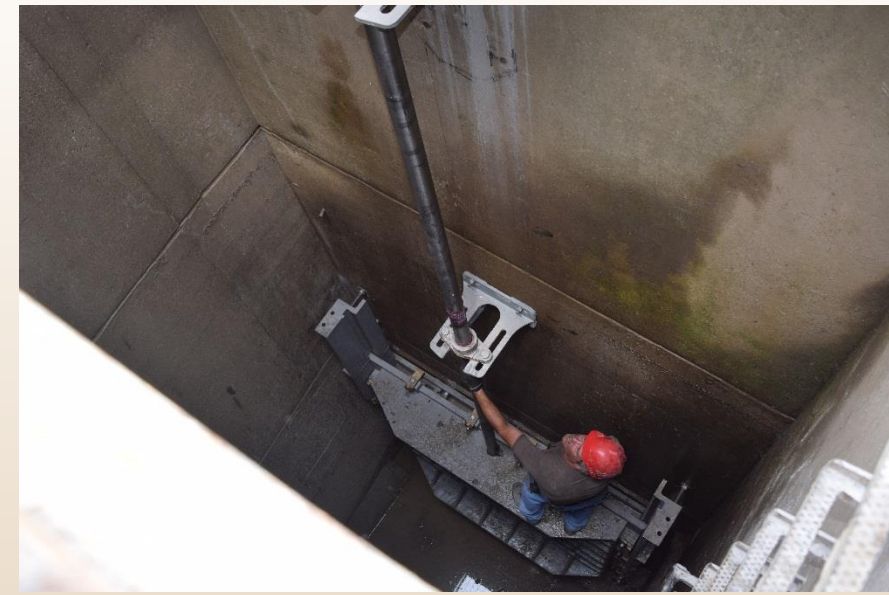
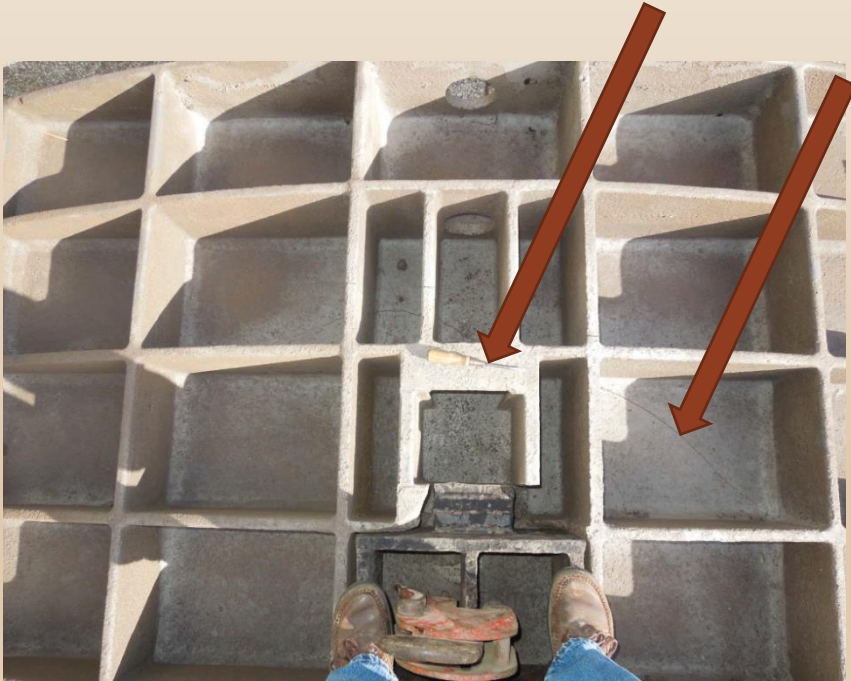
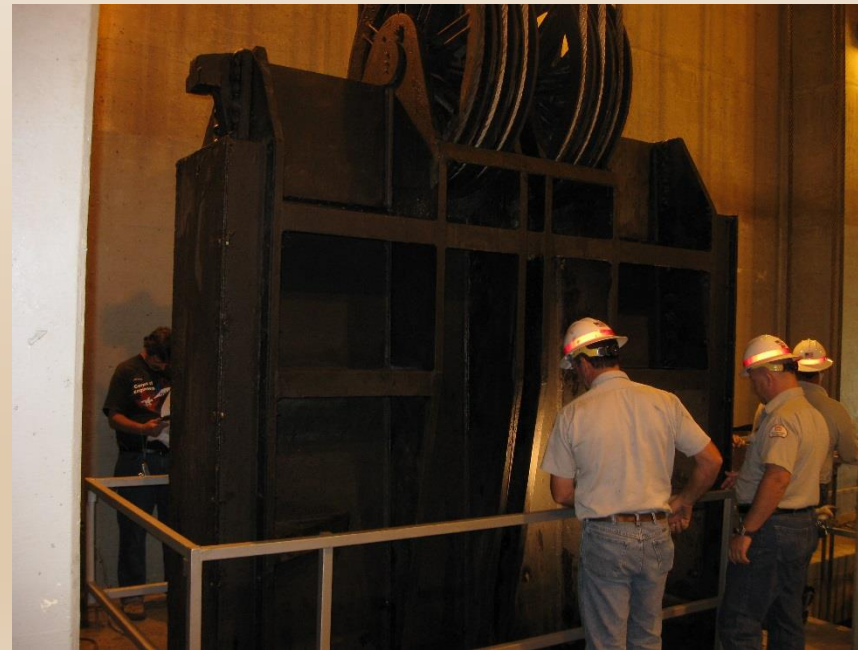
Sluice Gates

- Used both in Levees and FRM dams.
- For levees, used in gatewells to prevent backflow during floods.
- Generally cast steel (ductile) or cast iron (non-ductile behavior)
- Generally operated with steel stems but also may be hoisted with wire ropes

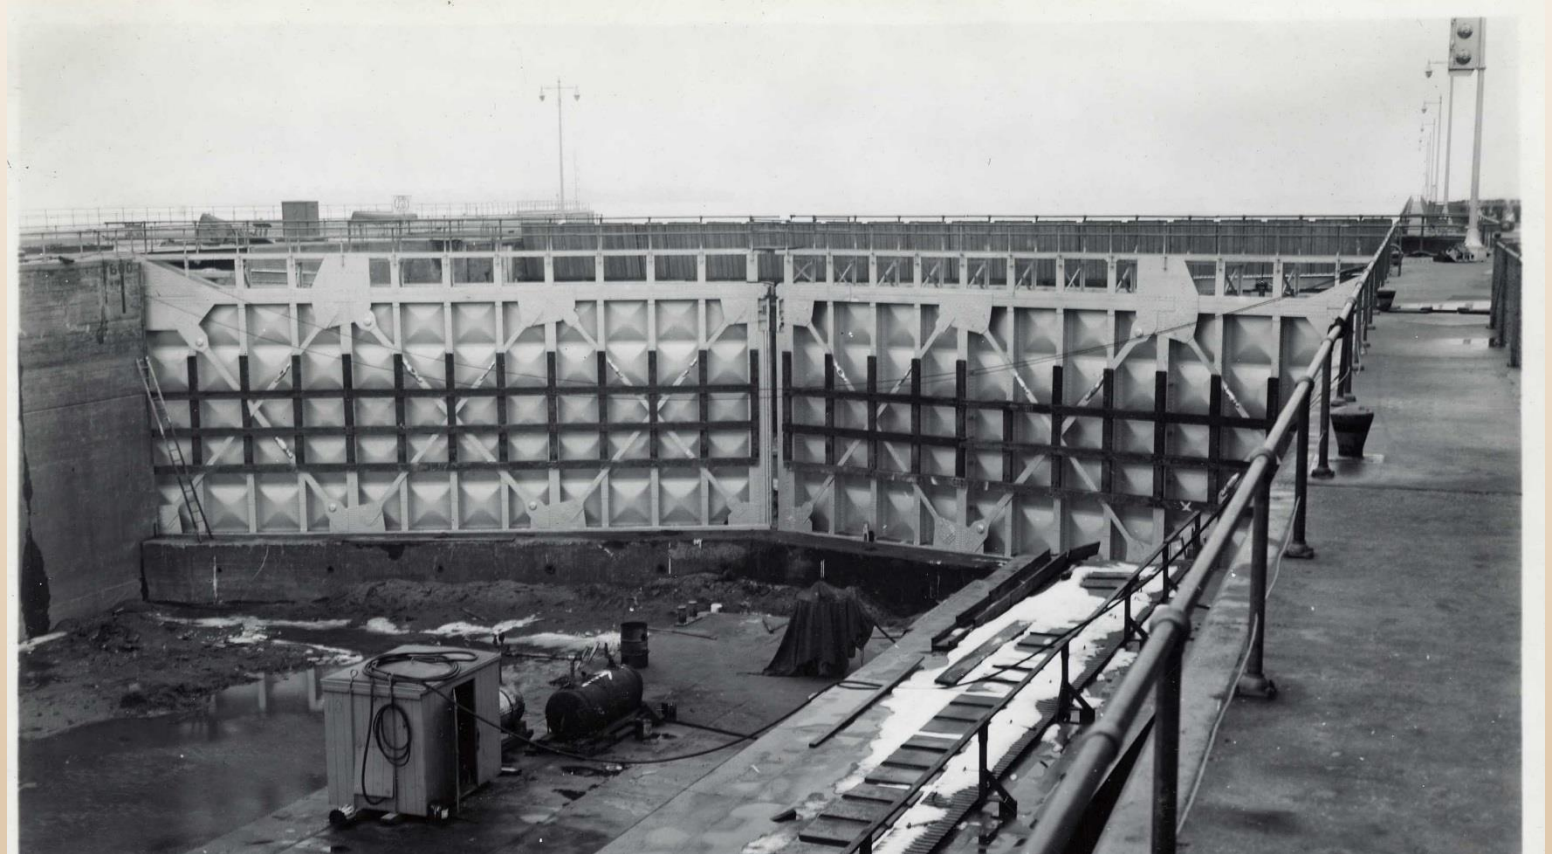
Vertically Framed Miter Gates

- Loads are transferred from skin plate to vertical girders.
- Load is distributed equally between the top horizontal girder and at each vertical girder's contact point with the concrete gate sill. Horizontal loads do not collect at the pintle.
- Photo from Mississippi River L&D 16 (1951)

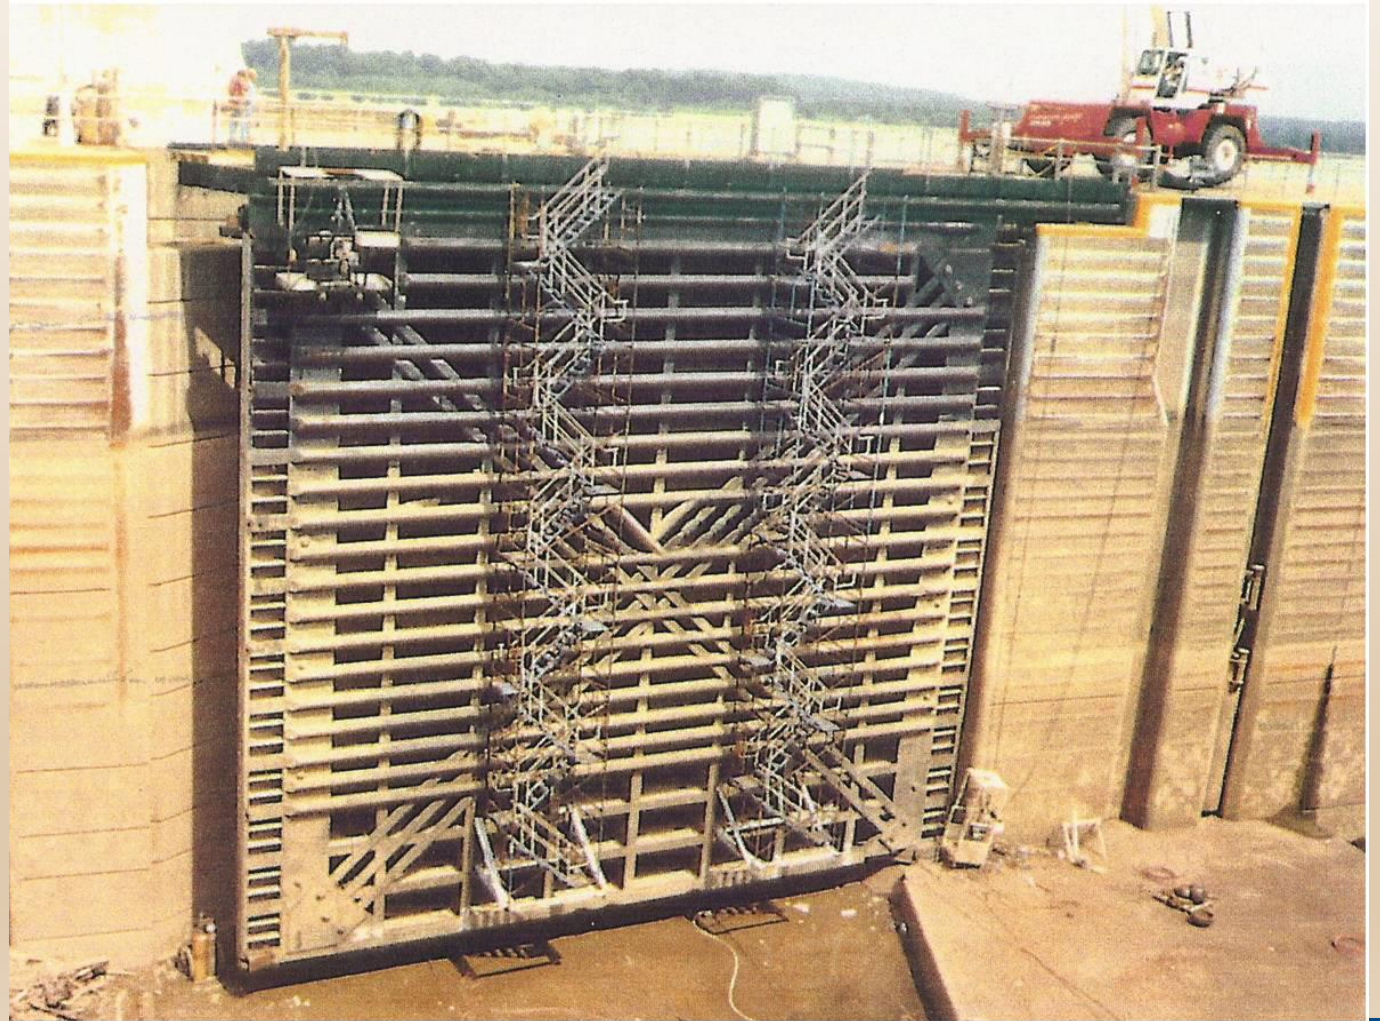
Horizontally Framed Miter Gates

- Hydrostatic loads are transferred from skin plate to vertical intercostals and from there to horizontal girders.
- The load from the horizontal girders is distributed to the quoin and miter posts.
- Horizontal loads collect at the quoin and miter contact blocks.
- Quoin block transfers horizontal loads to the lock walls from top to bottom.
- Miter blocks transfer horizontal loads to the other gate leaf's miter block.
- Horizontal loads should not be collected by the pintle (bottom) or the gudgeon pin (top).
- Photo from Cannelton L&D (Ohio River), 1980's

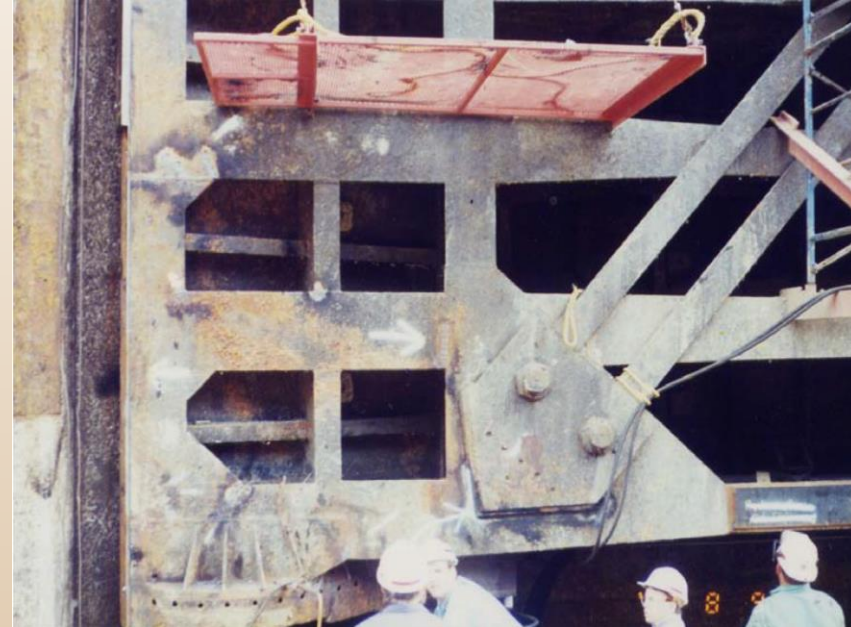
Fatigue Cracking of Miter Gates

- Severe cracking found at welded connections of horizontal girders in 1994.
- Gates considered to be in critical conditions and immediate repairs were done.
- Dewatering
- Gate was replaced in 2011 with a cost of \$12M.
- Ice Harbor had a similar design. Gates were replaced in 1996 with a two month outage and \$6.5M cost.

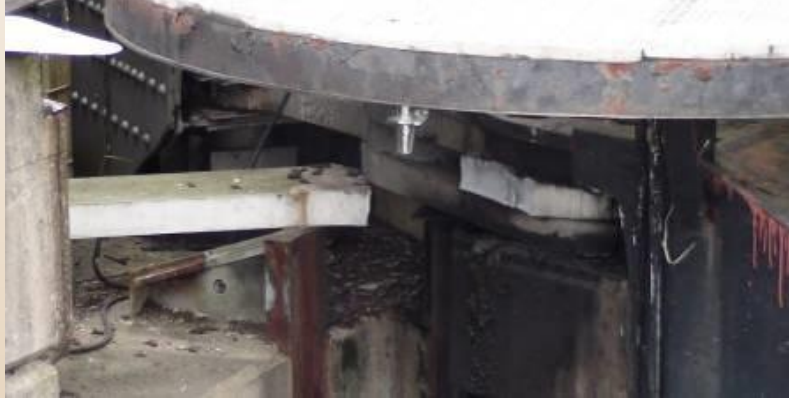
Failure of Miter Gate Anchor Arm Greenup Lock and Dam

- Sudden failure of anchor arm of main chamber miter gate caused a 26 day emergency closure.
 - The failure initiated at the root of a fillet weld connecting the miter anchor arm to the top connecting link and propagated through the entire cross section of the miter anchor arm.
 - The crack was not visible during prior inspections due to limited accessibility, paint and over spill of lubricating grease for the gudgeon pin.
 - Gate fell on the sill in a vertical position.
-

- Anchor wedge assemblies, anchor arms, connector plates, gudgeon and link pins were replaced and the gate was reinstalled on February 21, 2010. February 22, 2010 the main lock chamber was reopened for traffic

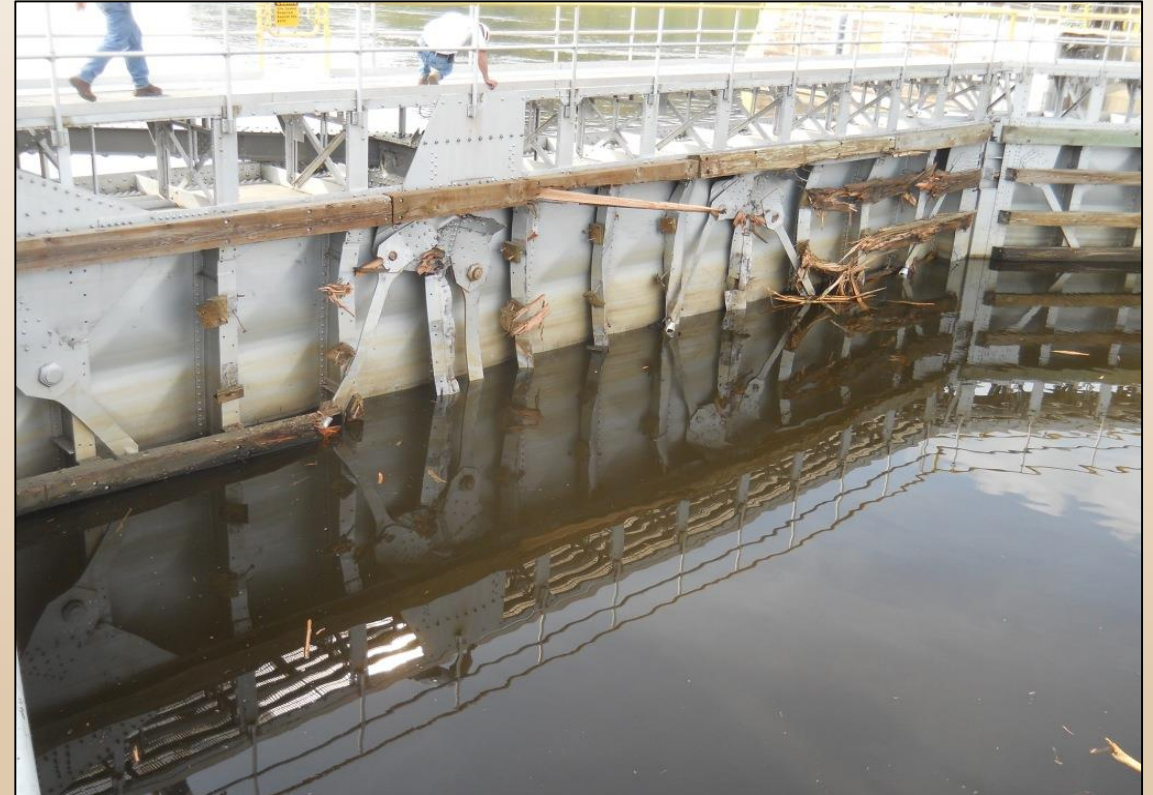
Typical Event Tree for Miter Gate Failure

- River is at normal low water condition (max differential)
- Tow enters chamber heading downbound
 - Upper gate leaves are activated from recess toward miter position, to close behind the tow
 - Existing crack in the gate leaf's upper anchor arm that has formed as a result of fatigue (200,000+ cycles) widens; top of gate rotates toward chamber floor
 - Operator does not notice gate is tilted from normal position and continues to operate gate
 - Upper anchor arm catastrophically fails
 - Gate falls into lock chamber floor
 - Navigation traffic is halted
